Title: Moisture-Induced TBC Spallation on Turbine Blade Samples

James L. Smialek

NASA Glenn Research Center

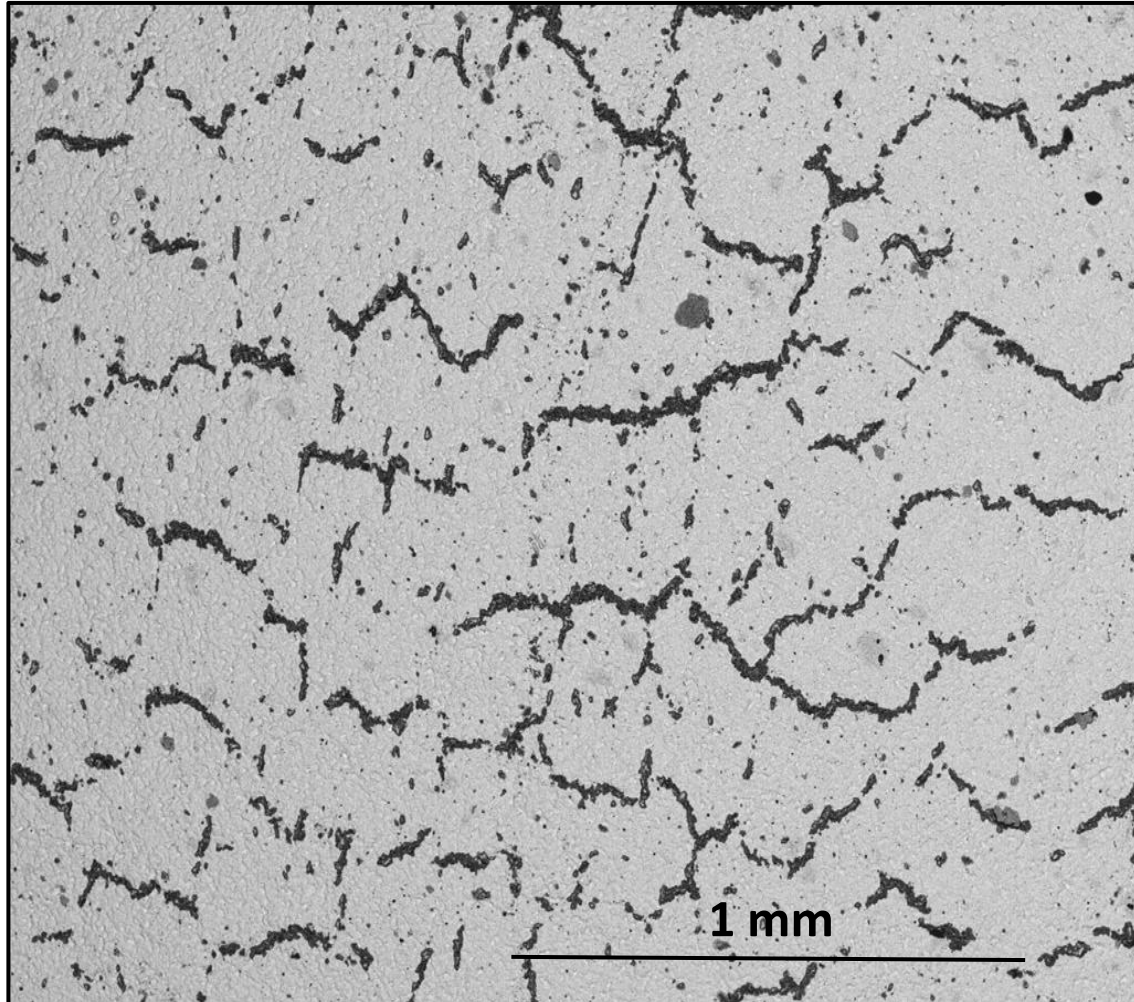
Figure 16

At the exposed side of the blade, much bare metal was revealed with an array of included alumina stringers, [Figure 16](#), spaced about 0.2 - 0.5 mm. These stringers are seen to be somewhat wrinkled, distorted and porous, [Figure 17](#), with numerous patches of bright particles found by EDS to be Ta or Zr-rich oxide. At higher magnification, the alumina stringers are seen to be highly convoluted lamellae and not dense. There are layered duplex grain morphologies indicative of multiple growth sequences, perhaps triggered by cyclic exposures, rumpling, and local detachment of the scale, but without removal by spallation. Finally, the oxide grain imprints, [Figure 18](#) are decorated with lower Al content lenticular precipitates, presumably an Al-depleted Ni-rich phase. Other bright areas, scattered sporadically over the bond coat surface, were noticeably Ta-rich.

Figure 16. Backscatter SEM image of the exposed metal surface showing a network of entrained alumina scale stringers. Sample B4, 35 hr intermittent oxidation at 1150°C.

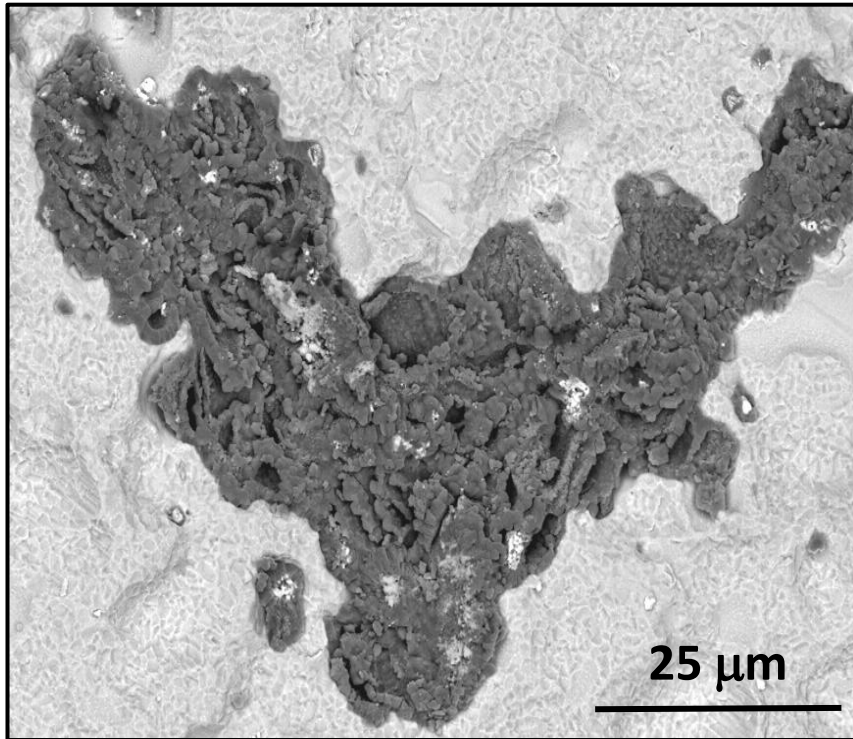
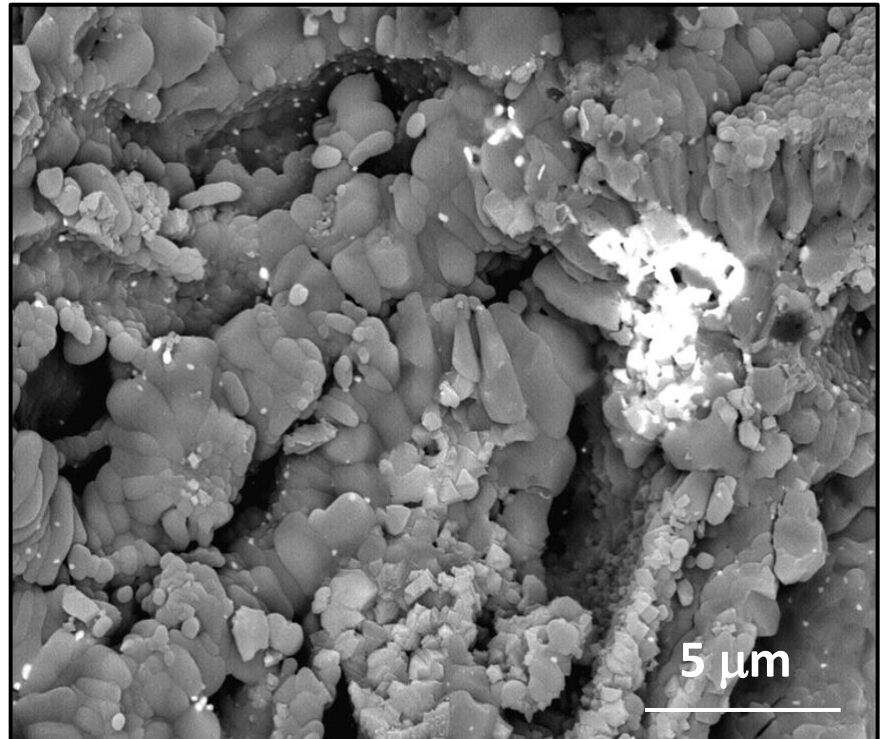
Figure 17

Figure 17. Higher magnification backscatter SEM image of the entrained alumina from Figure 16 showing separated lamellae and duplex grain structures. Sample B4, 35 hr intermittent oxidation at 1150°C.

Exposed Bond Coat Surface: B4, 1150°, 35 hr
 Al_2O_3 Stringer with Ta, Zr-Rich Oxide Inclusions

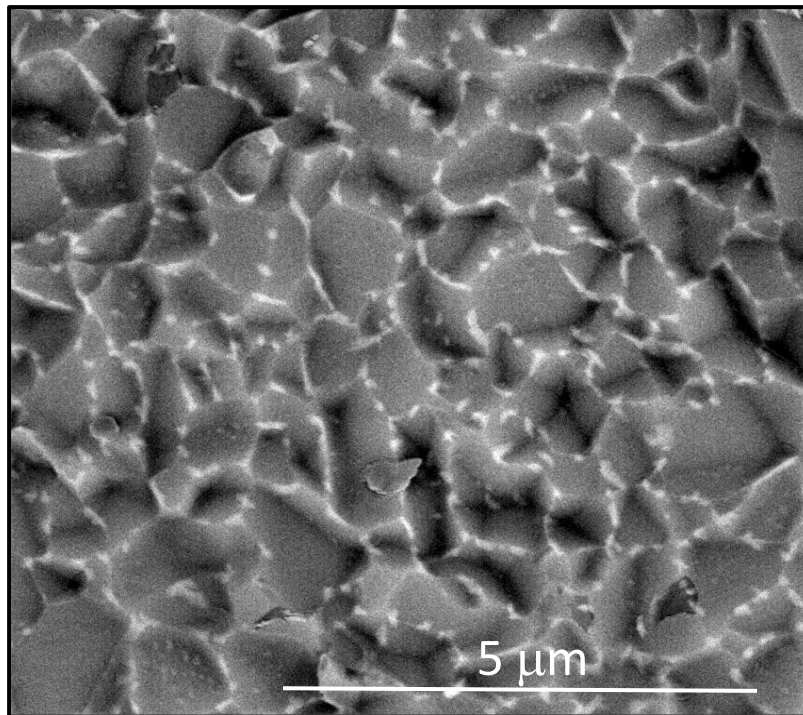
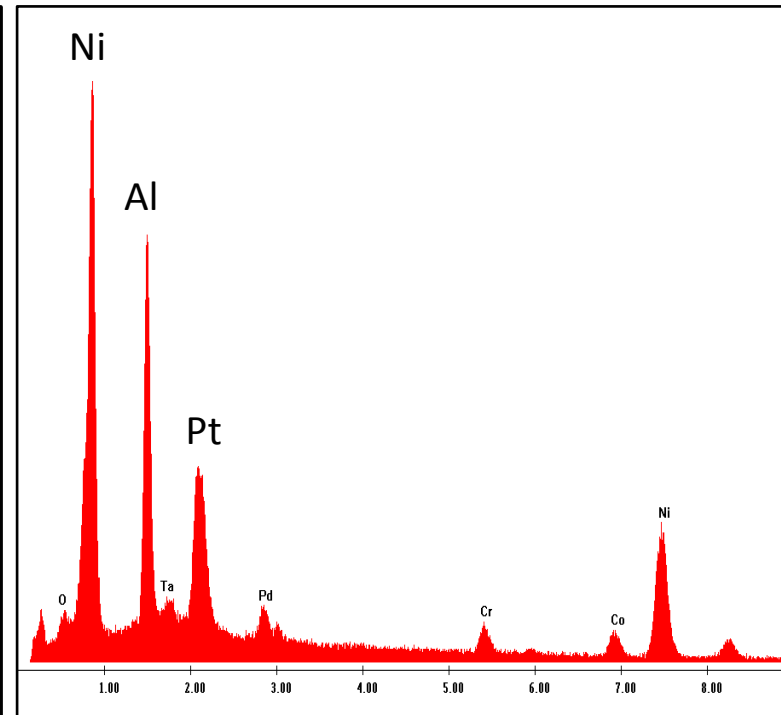
Figure 18

Figure 18. Backscatter SEM image of the exposed metal surface (and corresponding EDS) showing a alumina scale grain imprints, with boundaries decorated by Ni-rich lenticular particles. Sample B4, 35 hr intermittent oxidation at 1150°C.
